BA-1145

2434 Garrett Road

Maryland Inventory of Historic Properties Form

other Valley View Farm

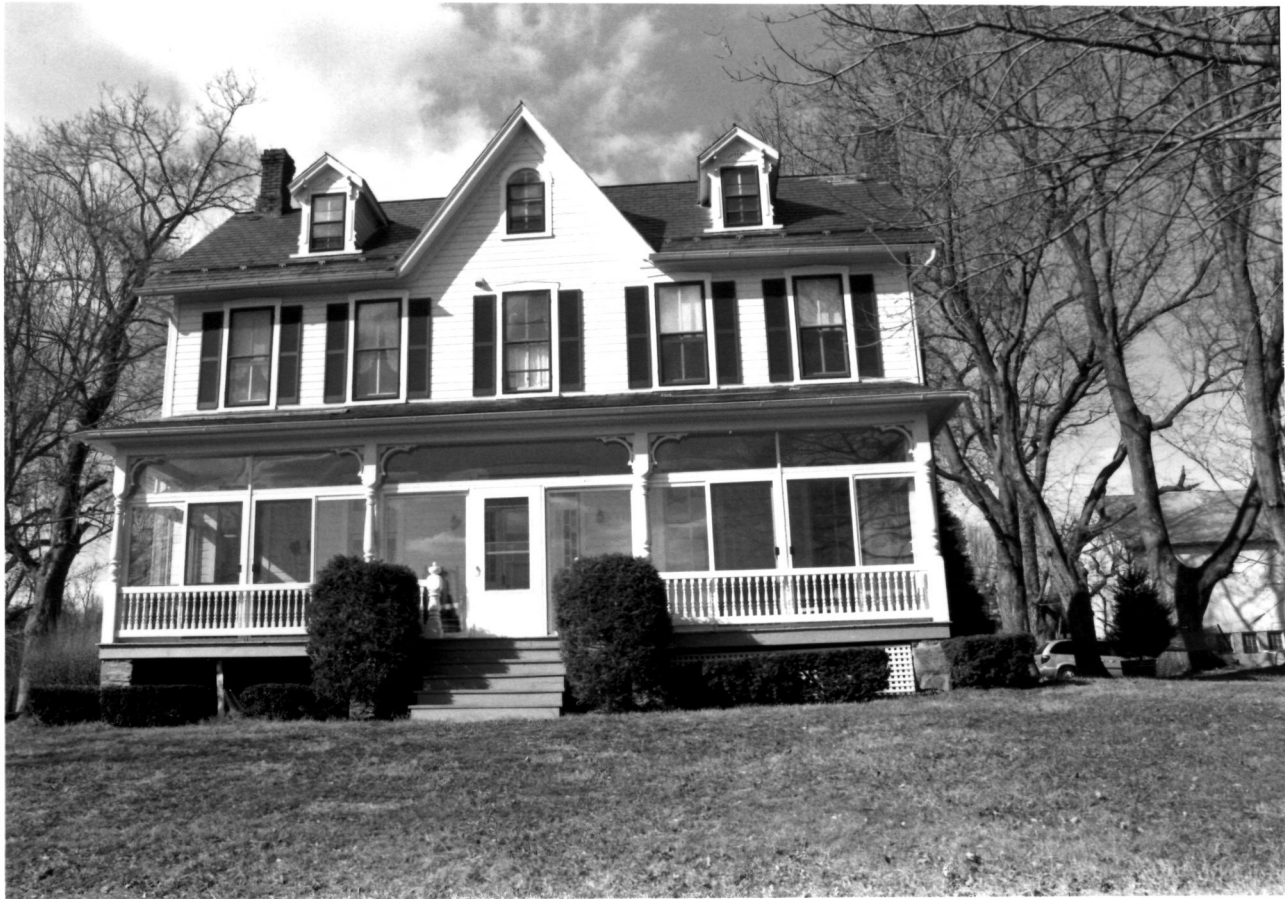
1 of 10

MAIN HOUSE, SOUTHWEST ELEVATION

On the first story of the façade, southwest elevation, the centered entry contains a single-leaf, wood-paneled door. The entrance is framed by 10-light/3-panel sidelights and an 8-light transom. The sidelights and transom feature stained glass panes. Two 2/4 wood-sash elongated windows flank the entry to each side. Five 2/2 windows with louvered wood shutters pierce the second story. All of the windows on the first and second stories of the façade feature wood surrounds with arched lintels that are slightly pointed. The center gable is detailed by a round-arched 2/2 window with a wood surround. Two gable dormers, each containing a single 2/2 window, flank the center gable. Ornamenting the dormers are raised panels on the surround, scroll-sawn brackets, and a decorative transom panel. Further adorning the façade is a full-width, three-bay wide porch with a shed roof, turned wood posts and balusters, imposing turned wood newel posts at the steps, and scroll-sawn brackets. The porch, now enclosed, is set upon a stone pier foundation.

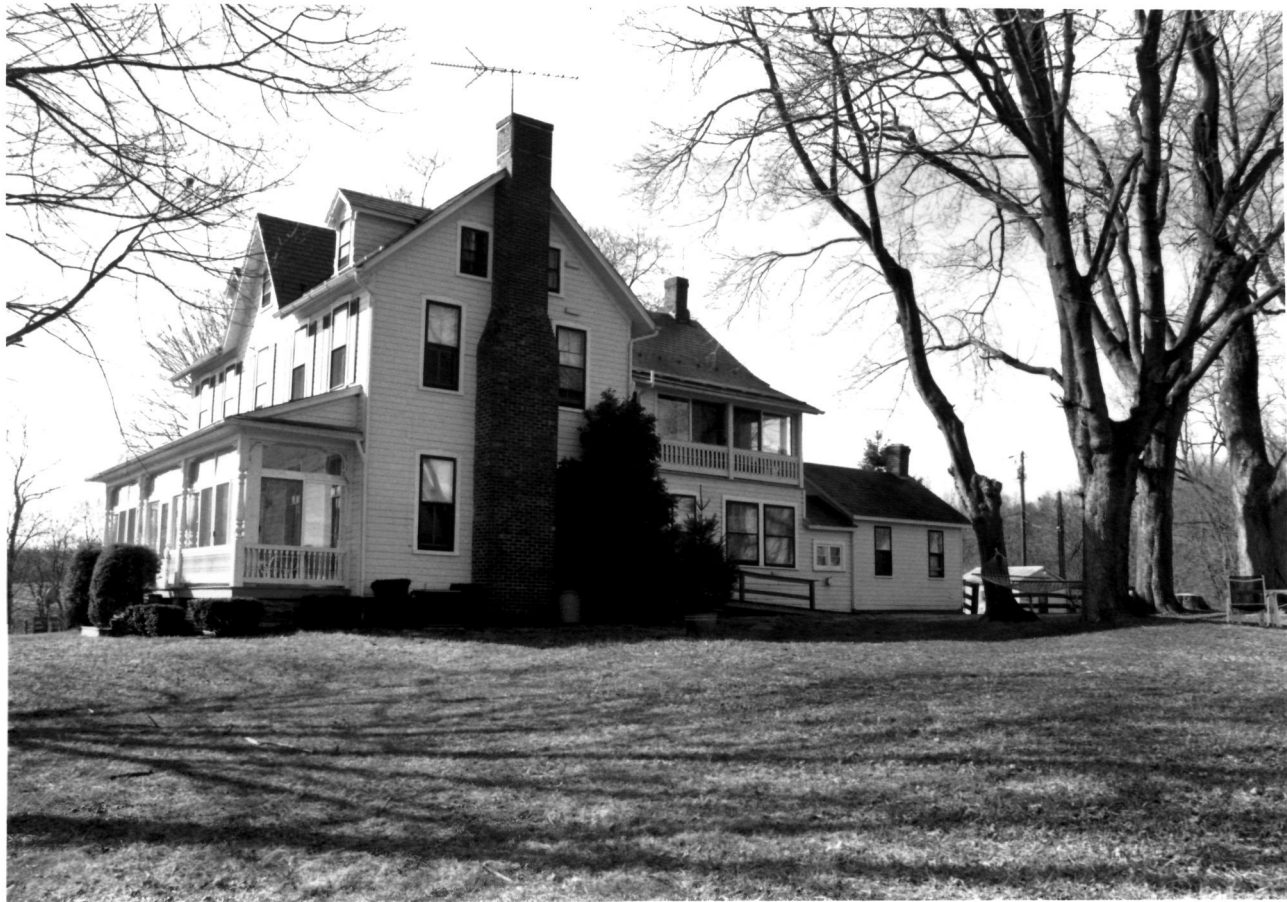
2 of 10

MAIN HOUSE, SOUTH CORNER

The southeast elevation of the main block, has a shouldered exterior-end chimney with stretcher-bond brick construction. Flanking the chimney are two 2/2 windows on each of the stories. The window surrounds are similar to those on the façade. The rear ell has a two-story shed-roof porch and gallery. The first story of the porch, has been enclosed, and contains two 8/8, one 4-light casement, and one 2/2 wood-sash windows. This elevation provides entry into the rear ell which contains a single-leaf 6-light/3-panel wood door. The gallery on the second story is supported with square wood posts and scroll-sawn balusters. The gallery is enclosed with 1-light sliding-glass doors. Flanking one side of the gallery is one 2/2 wood-sash window. The shed-roof hyphen is pierced with a 4-light casement window. The southeast elevation of the one-story kitchen is pierced with two 2/2 wood-sash windows.

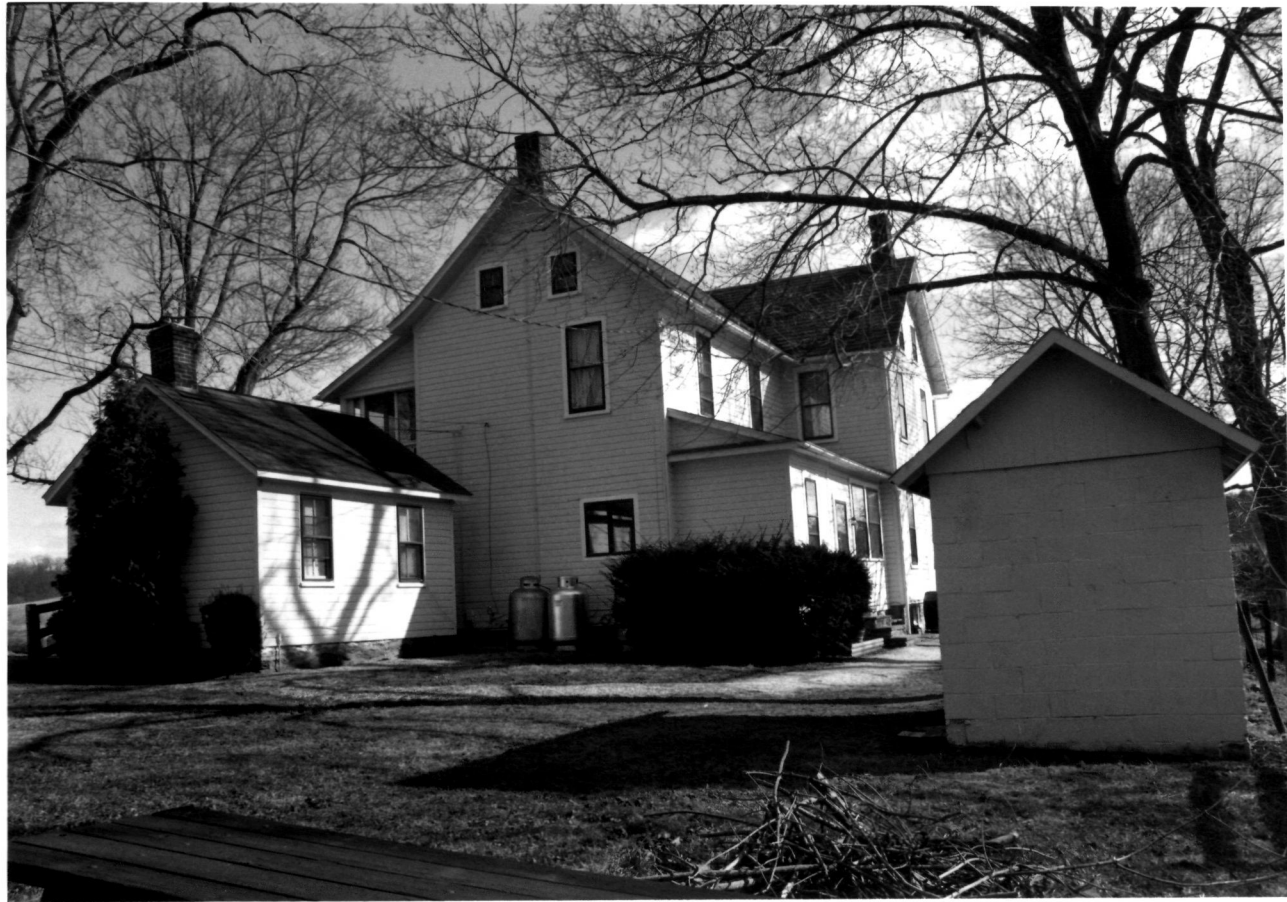
3 of 10

MAIN HOUSE, EAST CORNER

The first story of the northeast elevation of the rear ell contains a pair of replacement 1-light sliding windows. The second story has one 2/2 window and the upper half story has two 2/2 windows. A single 2/2 window is visible on the second story of the main block of the dwelling. A 12-light fixed wood window pierces the northeast elevation of the vestibule.

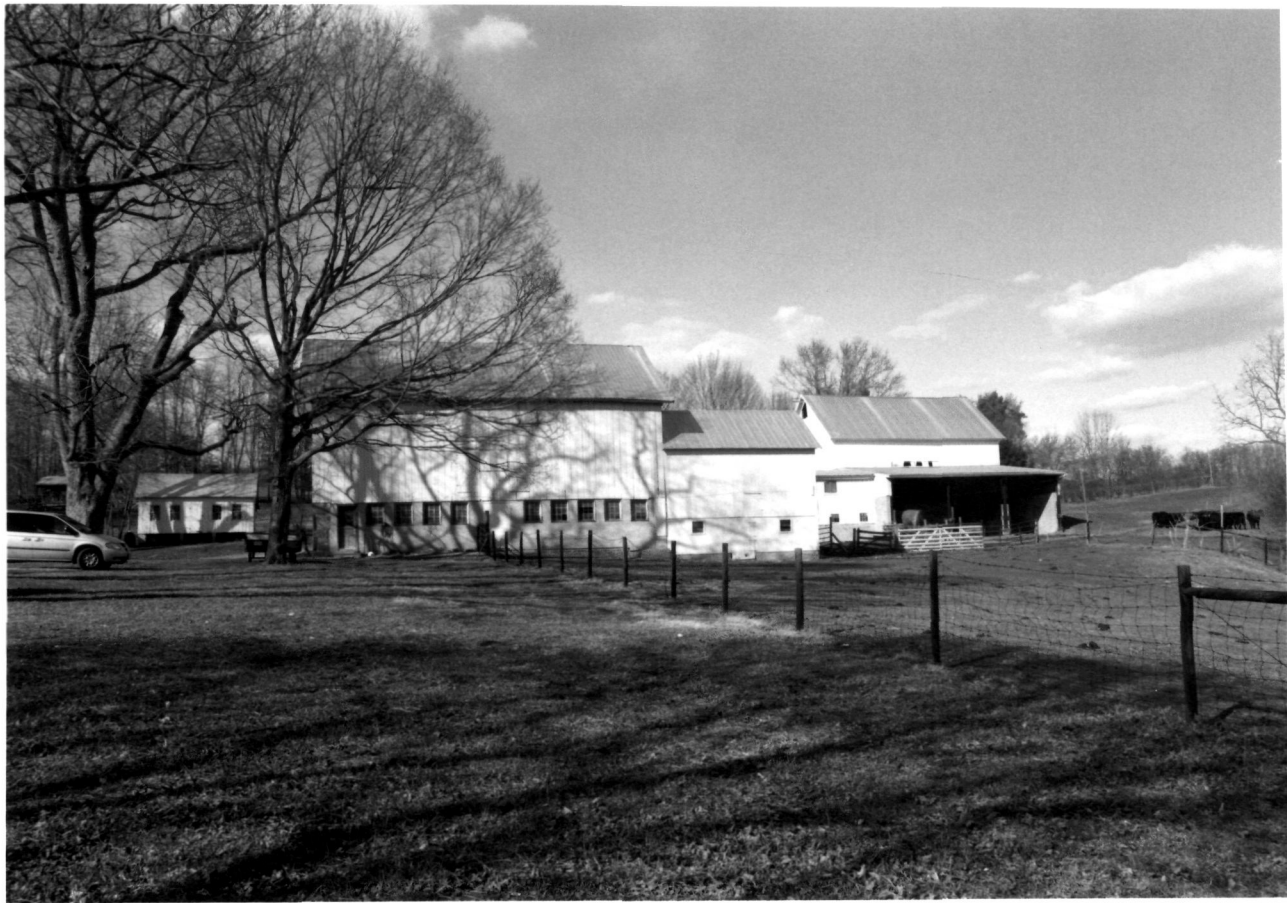
4 of 10

BARN, SOUTHWEST ELEVATION

The bank barn, constructed circa 1900, is set on a raised foundation that is partially constructed of stone and partially of concrete block. Clad in vertical board siding, the bank barn features a front-gabled roof of standing seam metal. The bank barn has numerous additions on the side and rear, ultimately connecting it to the other circa 1900 barn that stands to the east of it.

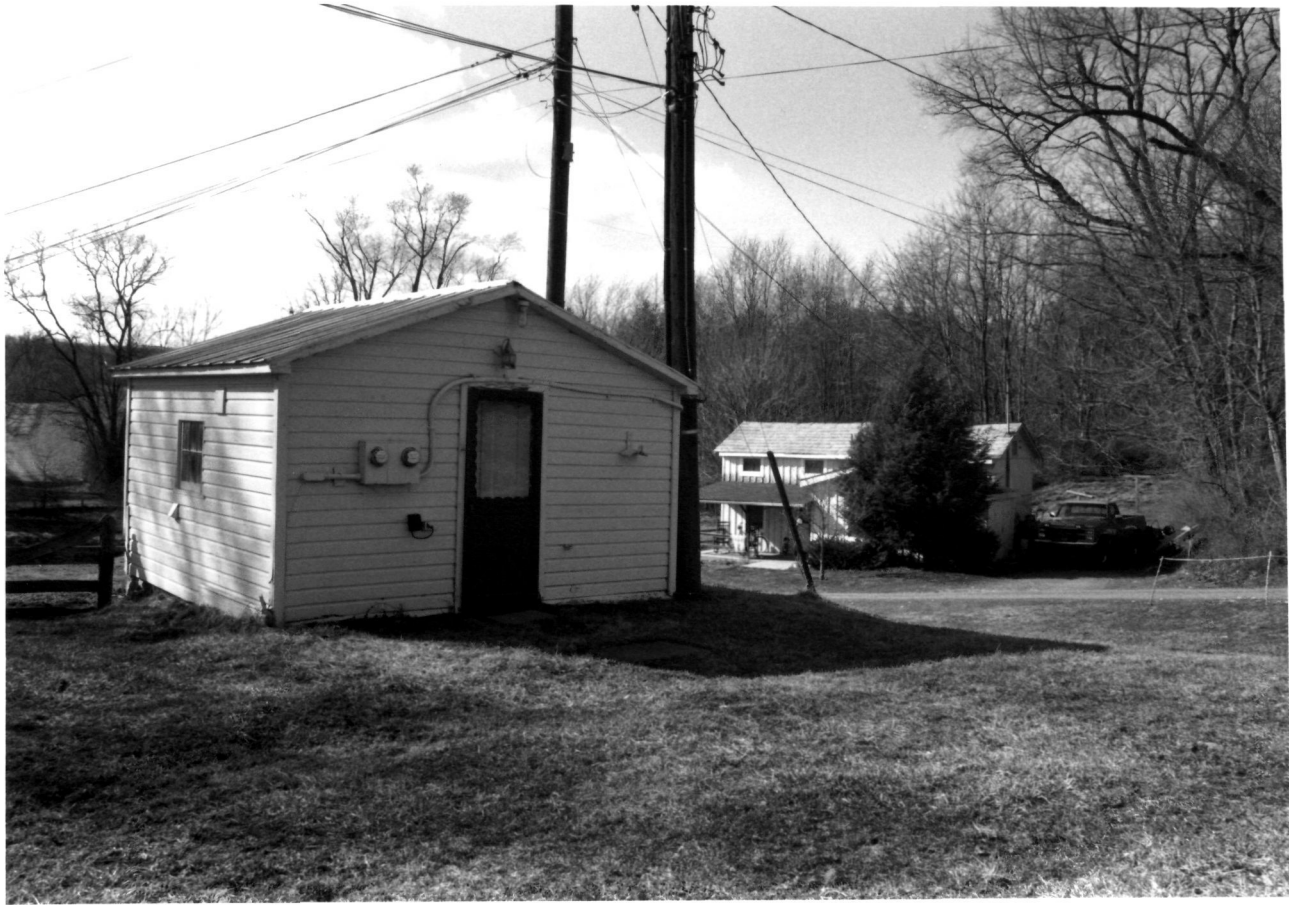
5 of 10

OFFICE # SINGLE DWELLING, VIEW LOOKING NORTH

Circa 1940, a one-story, one-bay-wide office was constructed to the rear of the main dwelling. It features a stone foundation, German siding, a single-leaf wood paneled door, and a front gable roof with asphalt shingles.

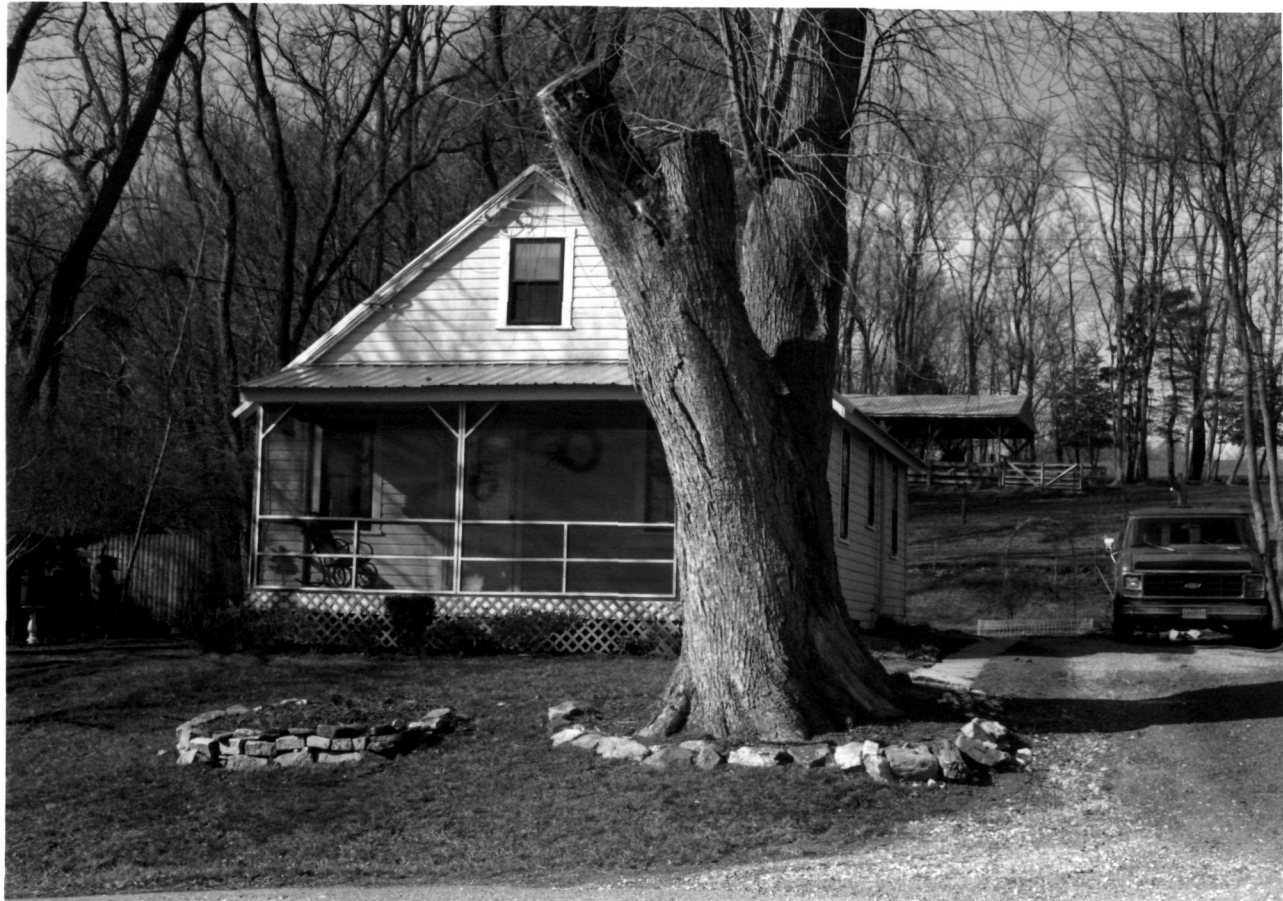
leaf 10

SINGLE DWELLING, VIEW LOOKING NORTHEAST

The property has three tenant houses, two of which are historic. The first, located at the northernmost part of the property, was constructed circa 1900. Clad in board-and-batten siding, the dwelling is two stories in height and features a side-gabled pressed metal shingle roof. Additionally, it features a shed-roofed porch and an addition with a front-gabled roof on the façade. The other historic tenant house was constructed circa 1940. Set on a parged foundation, the one-and-a-half-story, three-bay-wide bungalow is clad in German siding with cornerboards and features a shed-roof porch and a front-gabled roof with overhanging eaves.

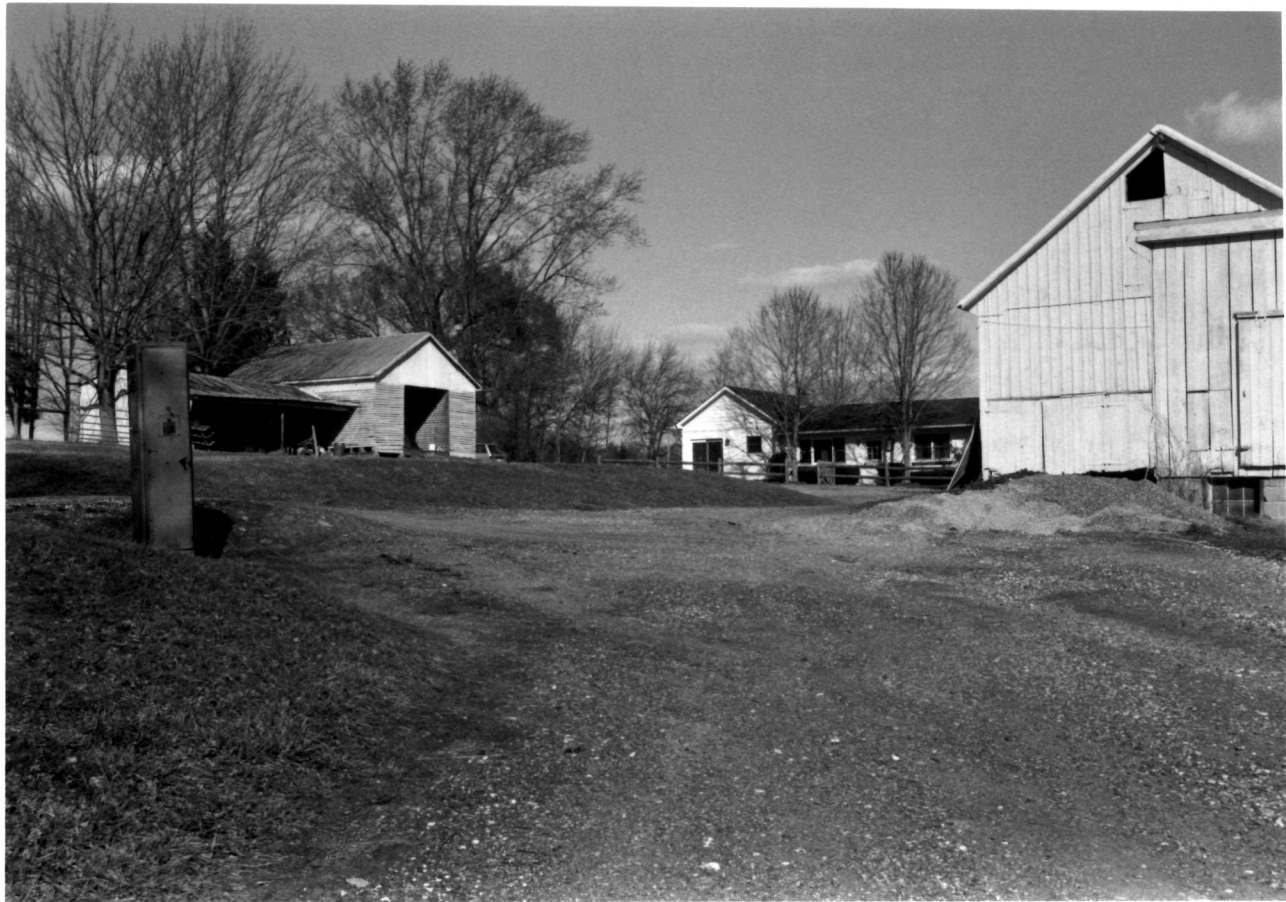
7 of 10

OUTBUILDINGS, VIEW LOOKING SOUTHEAST

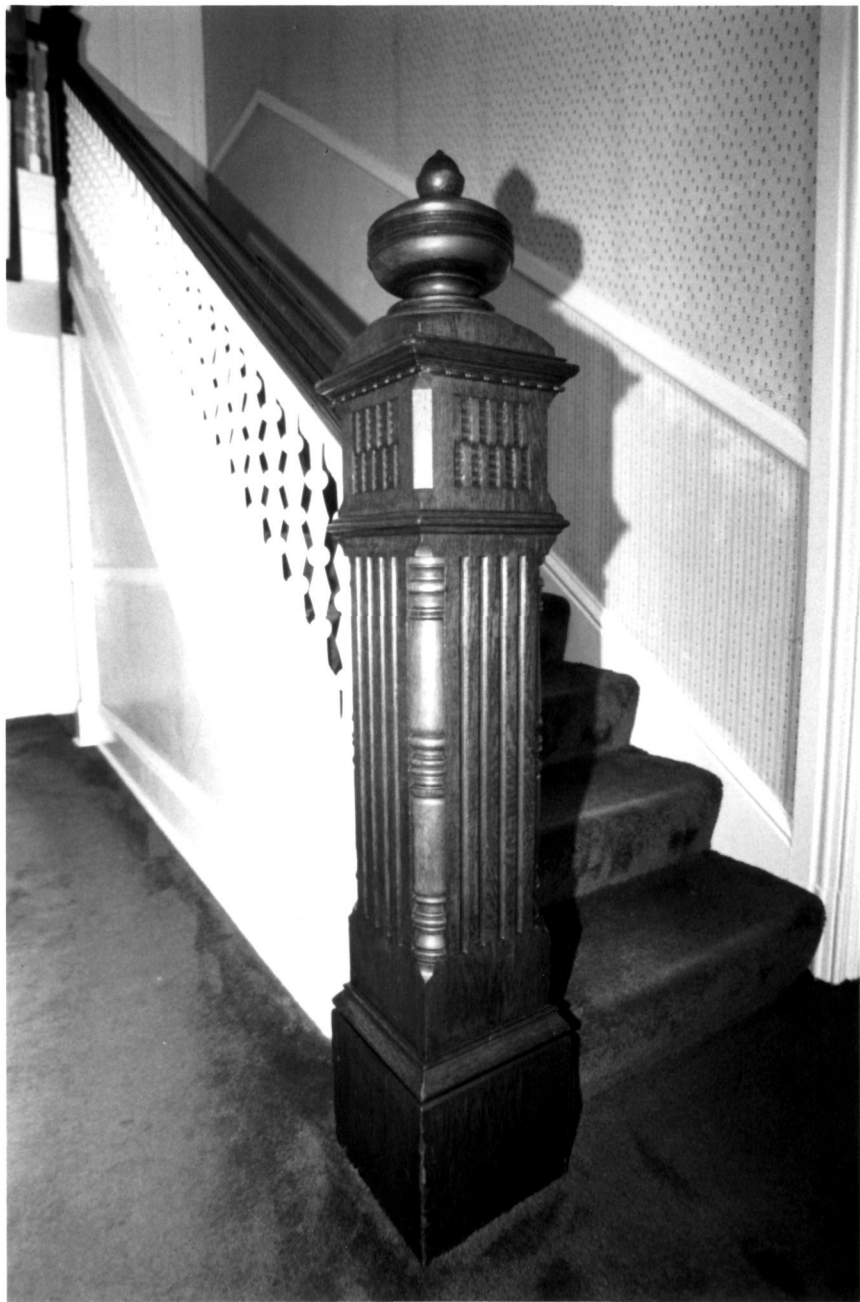
8 OF 10

FIRST FLOOR, CENTER PASSAGE, VIEW LOOKING NORTH

The main block of the house consists of a center-passage plan flanked by two rooms. To the rear is a small secondary hall which leads to the exterior and the rear ell. The center passage has a dog-leg stair supported with a large square newel post, turned balusters, and a heavily molded stringer. The shaft of the newel post is reeded with inset columns on the corners topped with a sculpted acorn and resting on a high plinth. The landing posts on the second floor have finials that extend below and are visible on the first floor. Thin wood replacement floorboards of the center passage are covered with carpet. The original lath and plaster

walls are covered with paper and the lath and plaster ceiling is painted. The original 9-inch wood baseboard is canted at the top edge and has a shoe molding. The original exterior door features three over eleven raised panels separated by a denticulated molding. The original door casing features bulls eye corner blocks and a cyma reversa, fillet, and astragal molding. The chair rail consists of two cyma reversa moldings connecting a fillet.

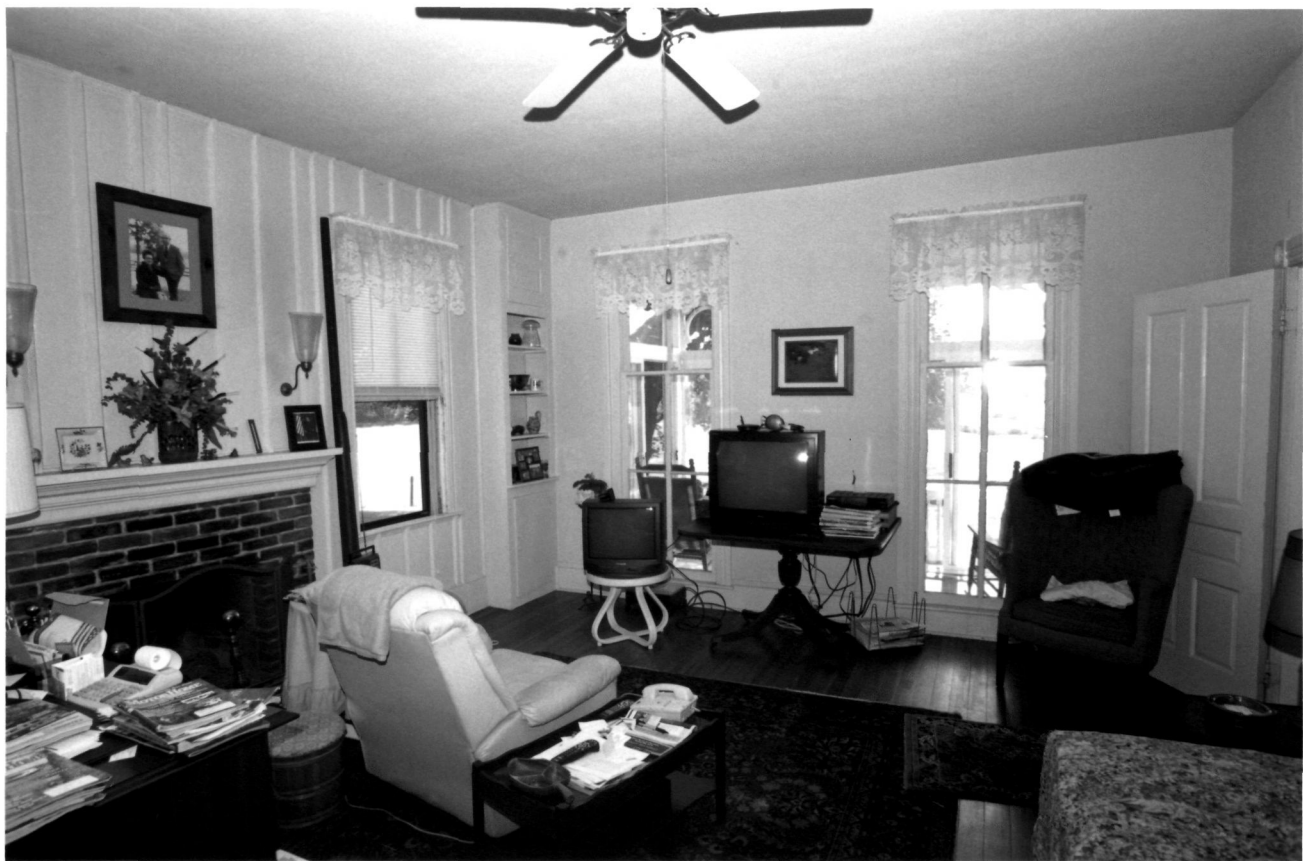
9 OF 10

FIRST FLOOR LIVING ROOM, VIEW LOOKING
SOUTHEAST

Southeast of the passage is the living room. The original lath and plaster walls and ceiling are painted. Similar to the hall are the floorboards and door casing. The original window casings are similar to the door casings. One original 5-panel wood door has a brass knob. The 9-inch baseboard has a small astragal, cyma reversa, fascia, and a shoe molding. The fireplace in the living room has a brick surround and hearth and a heavily molded lintel. The lintel consists of an ovolo, fillet, cavetto, fillet, chamfer, ovolo, and astragal molding. Alterations in the living room include the removal of the mantel surround and the application of pressed vertical boards and battens on the southeast wall.

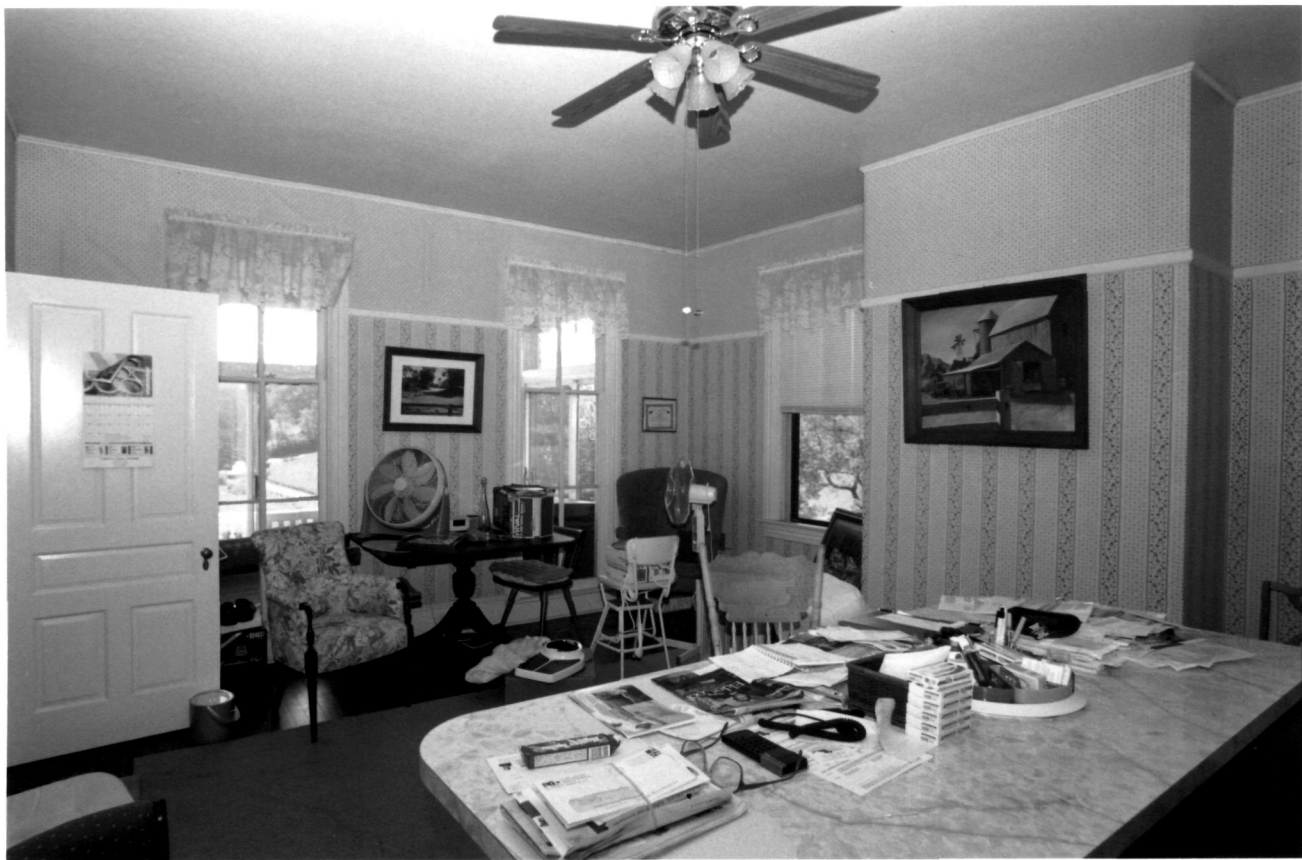
10 OF 10

FIRST FLOOR KITCHEN, VIEW LOOKING SOUTH

Opposite the living room is the kitchen. Features similar to those of the living room include the baseboard, floorboards, window and door casings, and five-panel door. The original lath and plaster walls are papered and the lath and plaster ceiling is painted. Around the perimeter of the room is a non-historic cyma reversa crown molding and a raised chair rail. Alterations to the kitchen include infill of the fireplace opening which was then covered with wall paper. A door on the northeast wall is blocked by non-historic cabinets.
